# BELZONA SPECIFIED PROTECTION OF SOAP PLODDERS

ID: 250

Silumin worms from soap plodders used in the manufacture of soap.

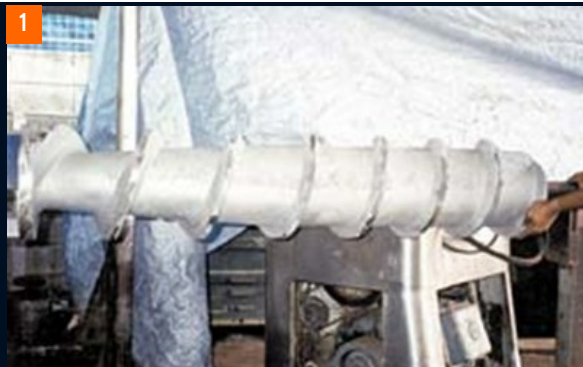
Wear and chemical attack of the worm's surface.

1. General view of plodder worm after cleaning
2. Application underway
3. Completed application

The application was carried out in accordance with Belzona Know-How System Leaflet SHM-14.
