# BELZONA BONDS MOBILE ANTENNAE TO WATER TOWER

ID: 260

Water storage tank

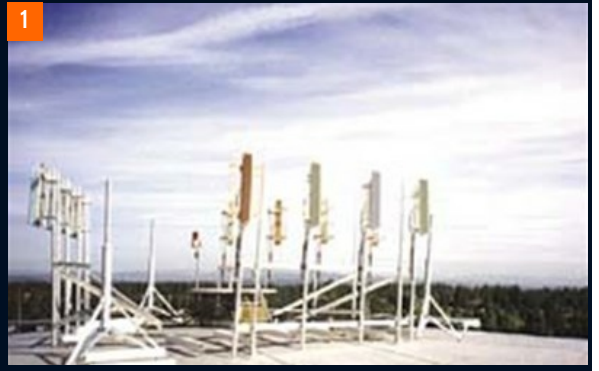
1. Antennas mounted atop the tank
2. Close-up of bonded pad for support
3. The finished job

Local mobile service provider needed an antenna for coverage in the area, but local sentiment opposed new towers. An existing water storage tank tower was selected, but welding supports to the tank had the potential to cause damage.

The application was carried in accordance with a modified version of Belzona Know-How System Leaflet TCC-3 and GSS-9.
