# CREATING FLEXIBLE GASKET WITH BELZONA 2131

ID: 263

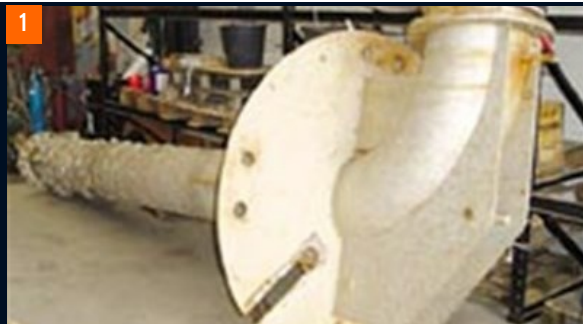
1. The pipe section
2. The corroded flange face
3. Former in place and Belzona 2131 injected
4. The Belzona gasket after removal of the former

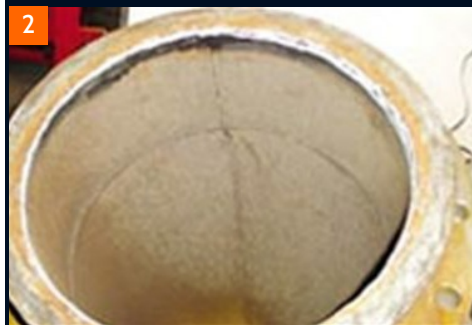
Electrolytic corrosion on flange face.
