# BELZONA REDUCES FUEL CONSUMPTION OF A HIGH SPEED PASSENGER FERRY

ID: 278

Jet drive coating on high speed passenger ferry.

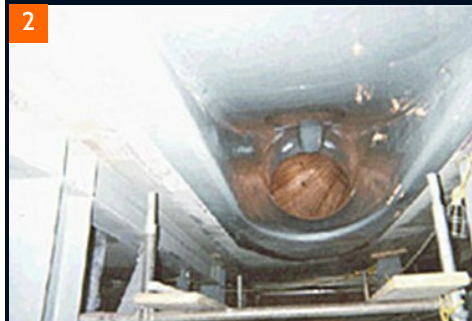
1. An overview of the passenger ferry
2. View of jet inlet (1st coat of Belzona 1341)
3. View of outlet coating complete
4. View of inlet (2nd coat of Belzona 1341)

The application was carried out in accordance with Belzona Know-How System Leaflet SOS-2.
