# BELZONA 4311 PROTECTS AGAINST SULFURIC ACID

ID: 28

Vertical pump used for mixing a sulfuric acid solution

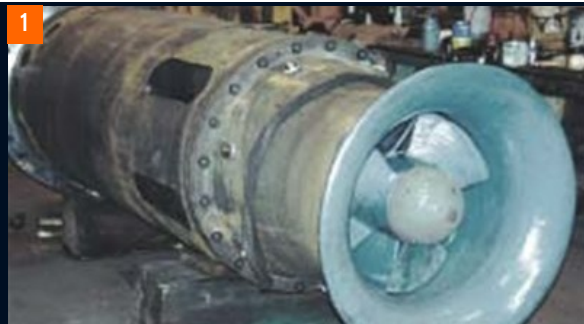
Chemical attack

1. The acid pump
2. Inside view following surface preparation by grit blasting
3. The satisfied contractor admiring his work

Tremendous cost savings resulted due to the fact that the very expensive mixing pump has been preserved. At this facility, five identical acid pumps were treated with two coats of Belzona® 4311 (Magma CR1).
