# BELZONA ALLOWS LUMBER TRANSFER ROLLS TO MAINTAIN POSITIVE TRACTION

ID: 285

Lumber transfer rolls with insufficient positive traction

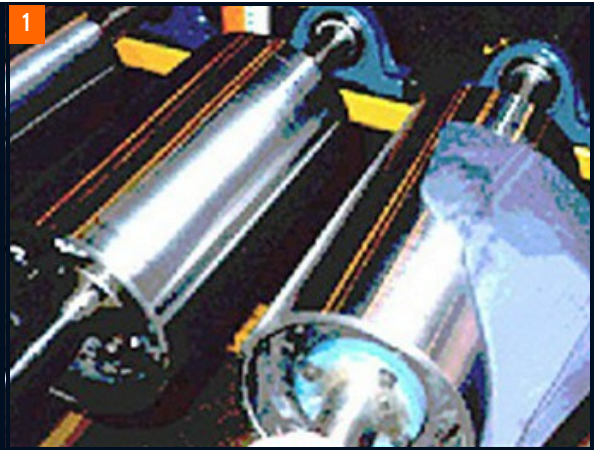
Saw mill rolls having problems firing the lumber in the correct direction creating short cuts, and crossover jams.

1. The equipment prior to the application
2. Belzona 1321 is being applied
3. Belzona 9211 is being broadcast onto the roller surface
4. The aggregate is being tamped
