# BELZONA PRESCRIBED AT UNIVERSITY HOSPITAL

ID: 293

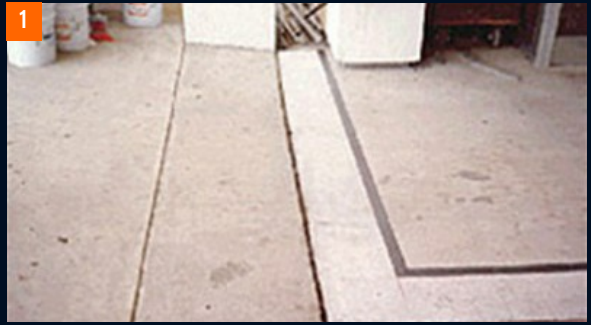
The entrance to the medical center was irregular from the concrete slabs settling "this is a high traffic area, with new born infant incubators, patients in wheel chairs, and sensitive instrumentation all having trouble crossing the area.

1. 1-inch transition between slabs
2. Troweling in the Belzona 4111
3. Finished application in front of the hospital

The application was carried out in accordance with Belzona Know-How System Leaflet FPA-1. Belzona® 4111 (Magma Quartz) was used to level the transition area between slabs, giving a smooth transition.
