# BELZONA PROTECTS CONCRETE FROM 50% CAUSTIC SOLUTIONS

ID: 3130

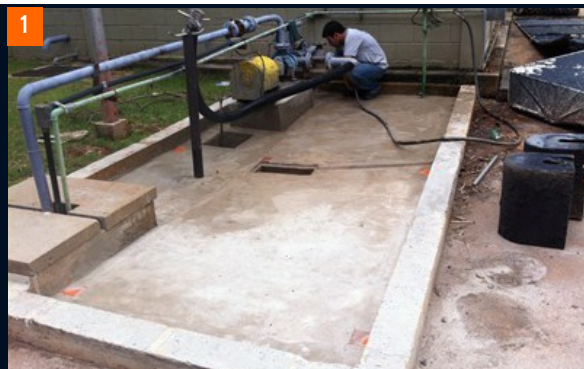
50% Caustic solution containment area coating had failed and needed re-coating.

1. Area to be coated.
2. View of drain.
3. Coating of Belzona 5891.
4. Completed application.

The application was carried out in accordance with Belzona Know-How System Leaflet TCC-15. Concrete was rebuilt and application of Belzona 5891 was complete with one coat.
