# BELZONA STRENGTHENS LAYDOWN DECK

ID: 3204

Offshore Oil Platform Laydown Deck

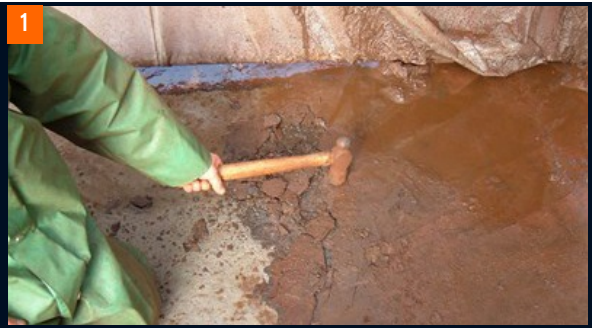
The deck had become weakened through daily operation (lowering/removal of containers) and weather. The original 8mm steel deck was corroded through wall in many locations. welding was not an option due to the installed underr-deck passive fire protection.

1. Condition of deck prior to starting work
2. Installation of deck reinforcement
3. Completed works
4. Inspection in 2015

A modified version of Belzona System Leaflet GSS-9 was employed. 5mm steel plates, drilled to accept jacking bolts and injection ports, were prepared by gritblasting and positioned onto the gritblasted deck. The jacking bolts were used to obtain accurate levels. The circumference of the plates were sealed using Belzona® 1111. Belzona® 5811 was injected into the void using an airless pump to seal and bond the reinforcement plate to the deck with 100% contact area being achieved.

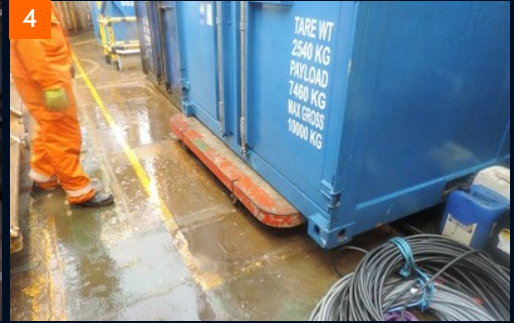
Independent testing showed that the Belzona bonding method in this case was equivalent in strength to a welded plate, stiffer AND more elastic than the original 8mm plate, good resistance to impact loading, and considered by the independent engineering designers to be "robust enough to withstand the rigours of laydown area operations. The key benefits were that daily operations were not interrupted and that the passive fire protection in the machinery space below would not be affected. This work has been inspected annually and has resulted in other deck strengthening projects being undertaken. Last feedback and inspection image received in 2015, engineers are still delighted with the work.
