# THERMAL EXPANSION/CONTRACTION IS NO MATCH FOR BELZONA

ID: 325

Steel wastewater process pipe through concrete floor.

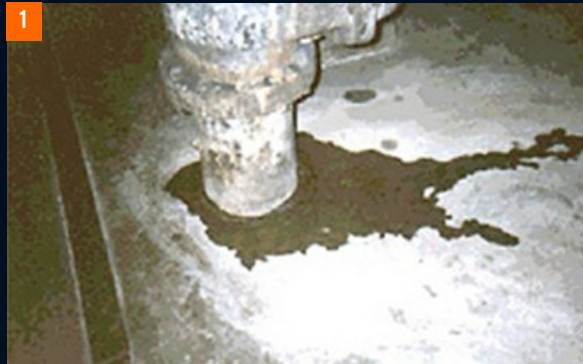
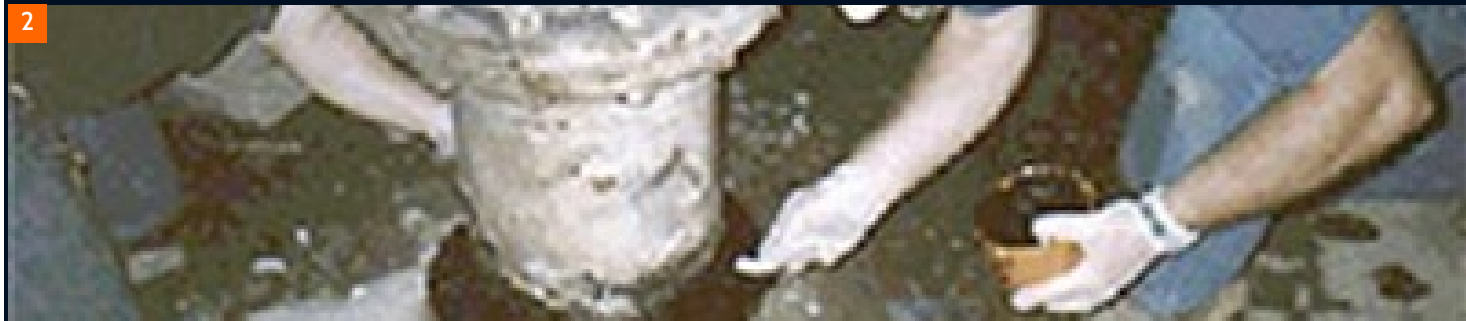
## PHOTOS

The concrete has a different coefficient of thermal expansion/contraction than the metal pipe. The result of this difference, is the erosion of the metal pipe at the interface, and subsequent leaks.

1. View of pipe leaking at the floor penetration
2. Repair completed with Belzona 4211 (Magma Stop) and Belzona 2131 (D&A Fluid Elastomer)

Belzona® 4211 (Magma Stop) was used to stop the active leak, without interrupting the process flow. Once the leak had been stopped, Belzona® 2131 (D&A Fluid Elastomer) was used to encapsulate the repair perimeter and absorb the movement of the two substrates. It is a good idea to rough cut around the perimeter of the Belzona repair and pour the elastomer in this joint to allow for movement.
