# DISCHARGE PIPES PROTECTED WITH BELZONA

ID: 3333

1200mm diameter discharge pipes

Phosphate plant, Mohammedia, Morocco

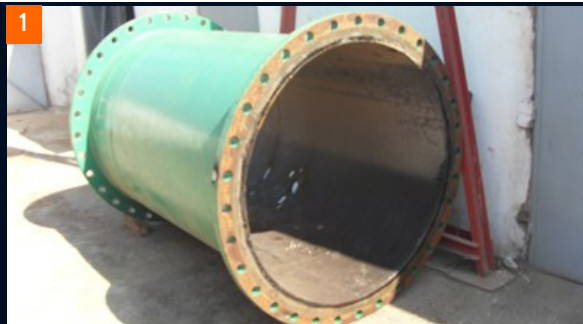
The discharge pipes were new, but required an erosion corrosion resistant lining to protect from the acidic slurry.

1. Original pipe
2. Gritblasted discharge pipe
3. Application in progress
4. Completed application
