# BELZONA STOPS ACTIVE JET FUEL LEAK

ID: 334

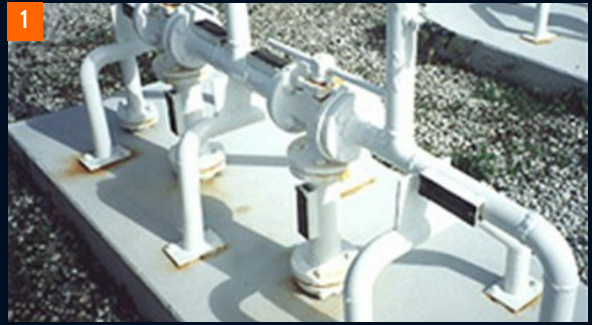
1. Several porous welds and threaded fittings of jet fuel distribution system sealed.
2. Close up view of threaded fittings. Jet fuel leak stopped.

Active JP4 jet fuel leaks through porous welds and active fittings.

The application was carried out in accordance with Belzona Know-How System Leaflet VPF-11a.
