# BELZONA GIVES THIS NEW COMBISORTER A MUCH LONGER LIFE

Internal wear surface of new combisorter unit.

Pulp and paper mill in the U.K.

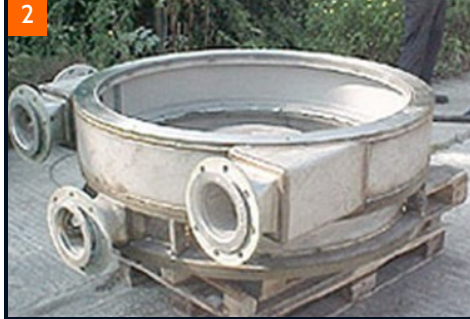
1. Combisorter prior to grit blasting
2. Combisorter with a three-mil blasted profile
3. Applying Belzona 1811 to the wear surface
4. Completely lined combisorter with Belzona 1811 (Ceramic Carbide)

The application was carried out in accordance with Belzona Know-How System Leaflet SHM-11.
