# BELZONA SEALS CARBON STEEL DIGESTER DOME

ID: 348

80 foot diameter carbon steel digester dome.

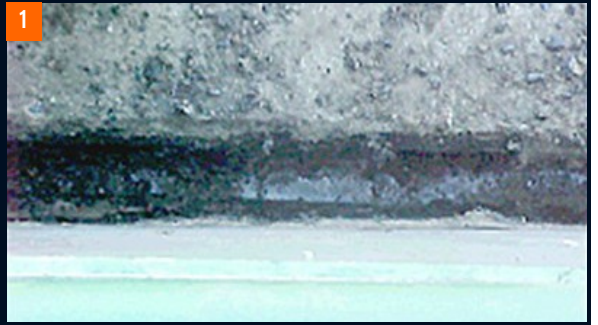
1. Three inches of original job excavated
2. Dome seal grit blasted and blown dry
3. Pouring of Belzona 2221 (MP fluid Elastomer)
4. 225 linear feet completed
