# BELZONA STABILIZES GAS PIPELINE ON BRIDGES

ID: 3541

Pipe bridges supporting gas pipeline over waterways.

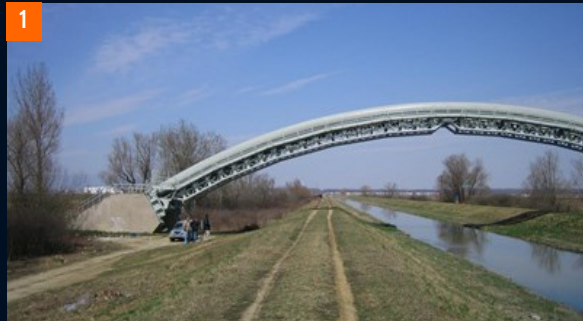
General view of pipe bridge  
Preparing/measuring location for supports Belzona 1111 used to bond wear pad Completed sliding support in place.

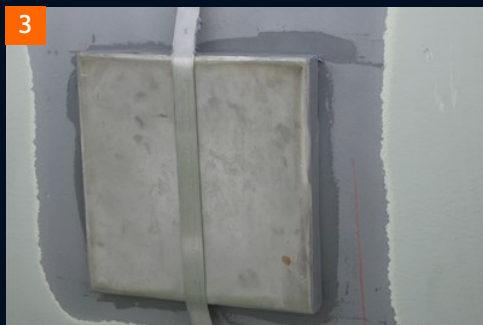
Every support is "connected" with pipe line via the slide assembly. The slide assembly needed to be fixed to the pipeline. Belzona® 1111 provides high strength bond without the need for hotwork, allowing work to progress without disrupting gas supplies. Since 1998, 5 such bridges have had supports bonded with Belzona without a single problem in that time.

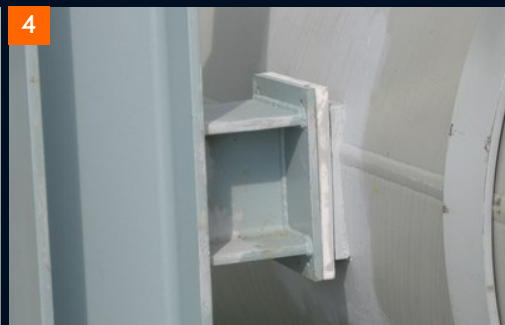
Customer needed to keep pipe line in fixed position. To achieve this several sliding supports between bridge and pipe had to be installed. Welding was not possible as gas line was active. Each bridge has 16 such supports.
