# BONDING FOAM CONTAINMENT DAM WITH BELZONA

ID: 362

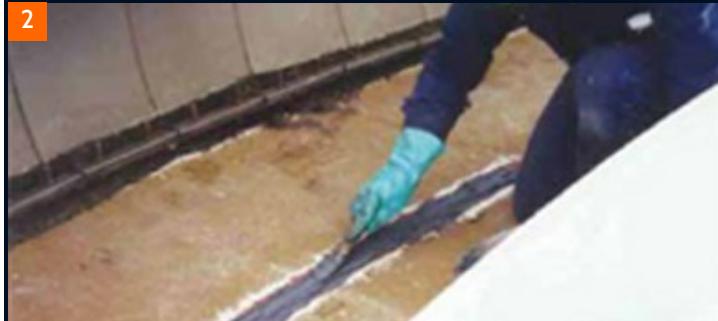
1. General view of the tank
2. Belzona 1111 being applied
3. Foam dam secured in place
