# BELZONA GRIP SYSTEM MAINTAINS BRAKE TEST EQUIPMENT

ID: 3644

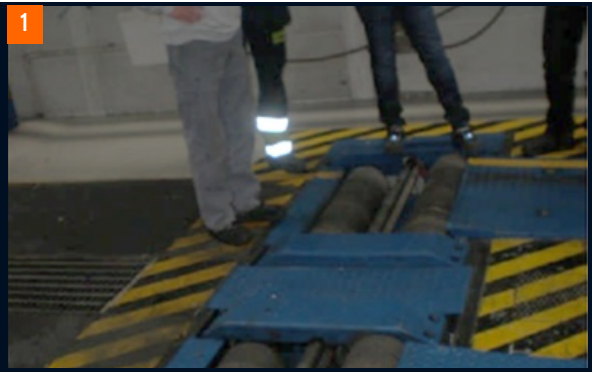
The drive rollers in the brake tester lose their grip and do not have sufficient friction with the tyre to complete an accurate test.

1. Worn rollers in the truck tester
2. Close-up of the worn roller
3. Roller coated with Grip system of Belzona 1321 and Silicon carbide aggregate, in the workshop
4. Finished application
