# BELZONA SECURES "A" BRACKETS TO YACHT HULL

ID: 368

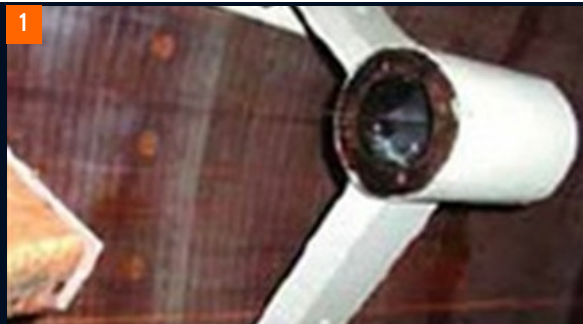
1. Bracket positioned using aligning wire and jacking bolts
2. Belzona 1121 being injected between hull and bracket
3. Completed application

The Belzona provides a high-strength irregular shim under "A" brackets ensuring no stress points on the hull. Non-slump properties of the Belzona important as gaps to be filled ranged from 3 to 25mm (1/8" to 1")
