# BELZONA RESTORES AND PROTECTS HISTORIC BATTLESHIP, NOW A FLOATING MUSEUM

327-Foot High Endurance Cutter - USCG Taney

U.S. Coast Guard/Baltimore Maritime Museum - Baltimore, Maryland U.S.A.

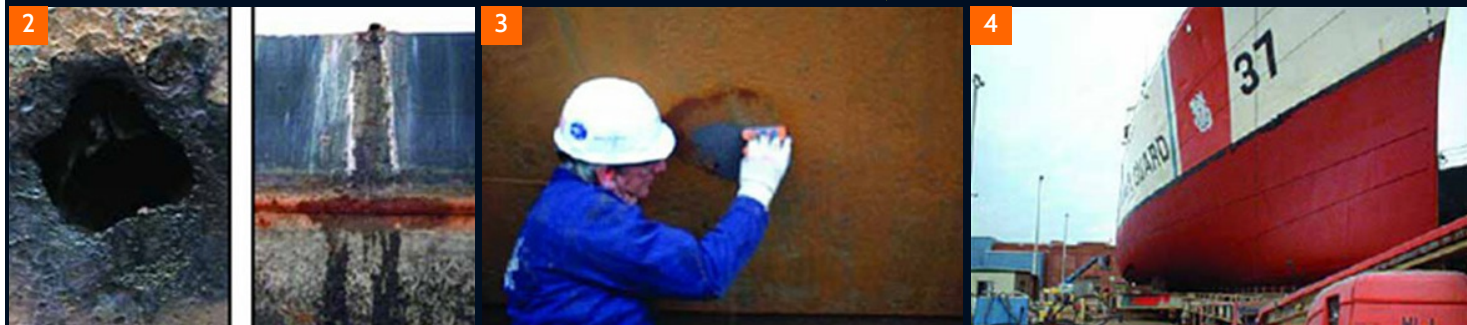
Badly corroded hull at and below the waterline.

1. An overview of the USCG Taney
2. Hull corrosion is clearly evident
3. Belzona 1111 is being finished
4. The Taney has been repaired, and is ready to go back in the water

The Taney is the last remaining warship afloat that survived the attack on Pearl Harbor. She now serves as a floating museum in Baltimore Harbor. Belzona® 1111 was used to fill in badly corroded areas. Following this an 18" band around the entire ship was protected with Belzona® 5811.
