# BELZONA SAVES SCHOOL DISTRICT OVER \$10,000

ID: 374

Insulated ductwork - HVAC

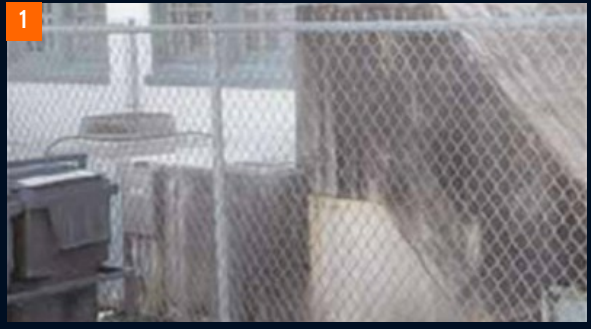
The insulated ductwork had a severe moisture problem. A product that would allow the moisture to dry as well as seal up the problem areas was needed.

1. The ductwork
2. Application in progress
3. The finished job
