# BELZONA BONDS SUPPORT PADS AND RAILS

ID: 402

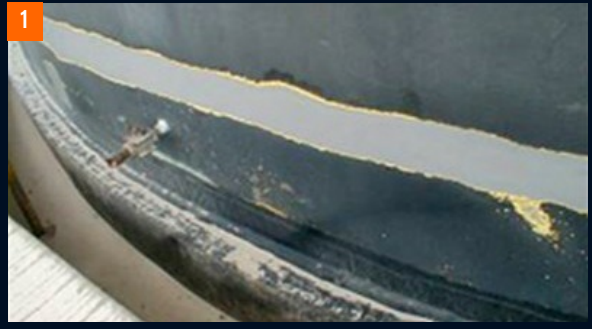
1. Surface preparation consisted of blasting the exterior metal surface of the tank.
2. Soon thereafter, the pads and rails were installed using the Belzona 1111.
3. The thermal insulation pads are being installed, using the rails as support members.
