# BELZONA PROVIDES HIGH TEMPERATURE CORROSION PROTECTION IN VESSEL

ID: 4046

Internal lining required for vessel processing high temperature hydrocarbons and water

High temperature vessel lining

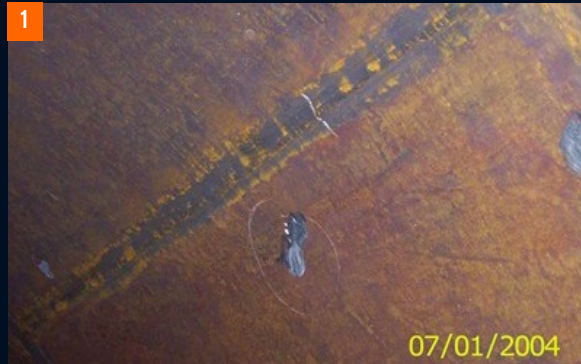
1. Corroded surface
2. Surface after preparation
3. Application process
4. Completed application
