# BELZONA COLD BONDING SOLUTION FOR SKIMMER

ID: 4163

Oil Skimmer

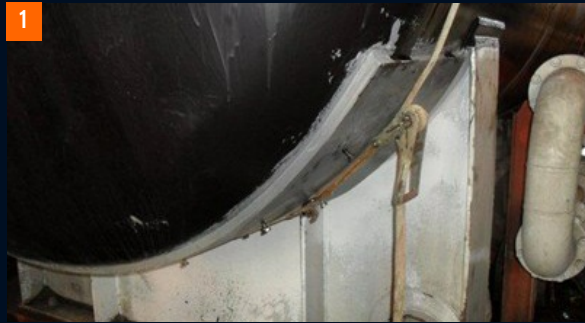
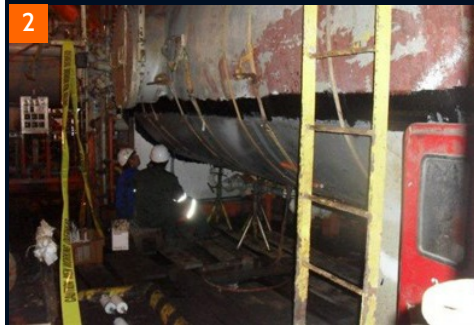
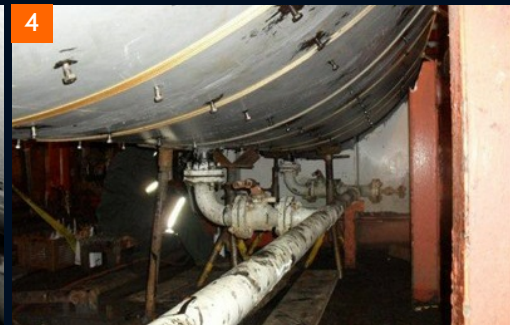
The skimmer, working in an open environment meters above the sea, had numerous holes and was continuously leaking. Welding was not an option for repair because of the hot work involved.

Bottom half of the skimmer coated with Belzona 5811 and one of the plates in place with a fillet of Belzona 1111 sealing the edges Application in progress Close-up of the injection process Completed application

The application was carried out in accordance with Belzona Know-How System Leaflet GSS-9. Metal plates were prefabricated ashore about 10mm larger than the existing vessel. After surface preparation, the plates were located on the vessel, the edges sealed with Belzona® 1111 and Belzona® 5811 was then injected through strategically arranged series of injection ports to ensure air was not trapped and the entire void between plates and vessel wall was filled with Belzona® 5811.

The cold bonding solution avoided hot work and was completed in just 3 days. This engineered solution ensured the skimmer could continue in service for many more years.
