# BELZONA GRIP SYSTEM INCORPORATED IN FISHING VESSEL

ID: 4189

Fishing Trawler, Peterhead, Scotland

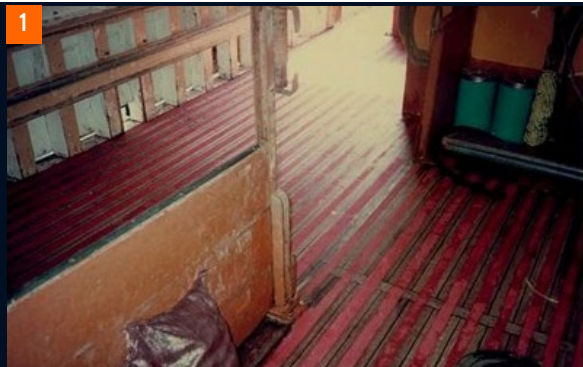
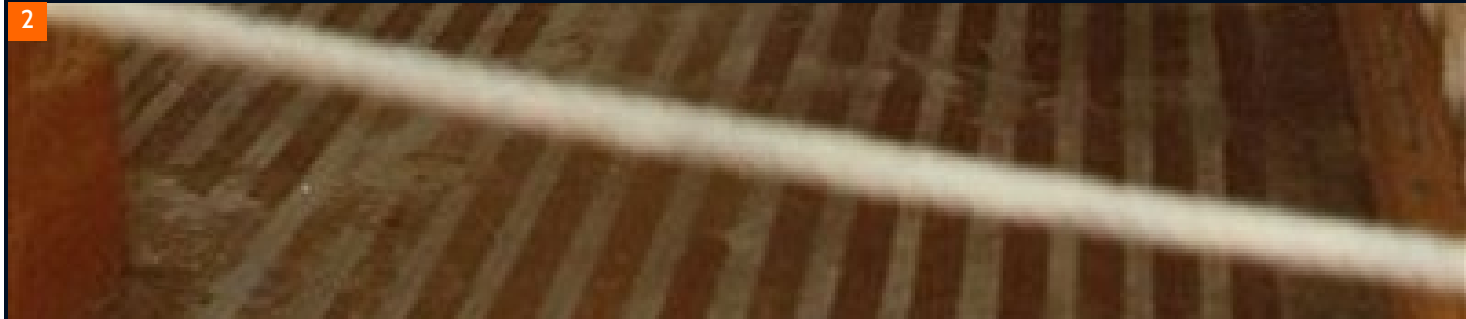
## PHOTOS

Wooden decking in the fish hold and on the working decks make for slippery hazardous conditions.

1. Before the application.
2. After the application.

The wooden deck is firstly routed and then the Belzona® 4411 (Granogrip) incorporating aggregate is applied into the rebate to maintain a flush surface yet create an aggressive grip system across the area.
