# BELZONA WATERPROOFS NATURAL STONE FACADES

ID: 4204

Natural Stone Facades

Private Building, Amman, Jordan

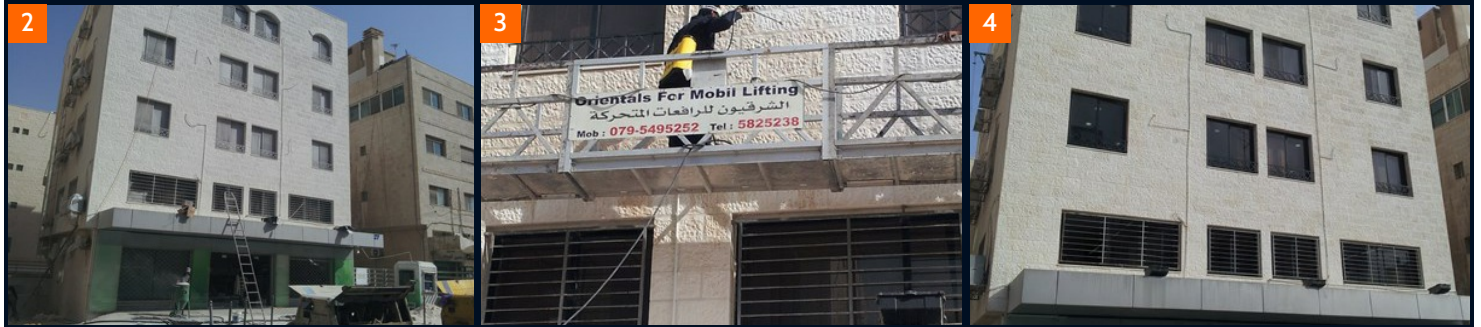
Water was penetrating the stones, creating damp areas on internal walls. The owner of the building needed to waterproof the structure and retain the natural appearance of the stones.

1. Front view of the building before application
2. Front view of the building after sand blasting
3. Applying Belzona 5122 with spray unit
4. Front view of the building after finish of application

The Application was carried out in accordance with Belzona Know-How System Leaflet WPA-8.

Belzona® 5122 Water Repellent Material protected the external structure from water penetration and gave the building new natural appearance
