# BELZONA PROTECTS CHEMICAL VESSELS FROM NEW

ID: 421

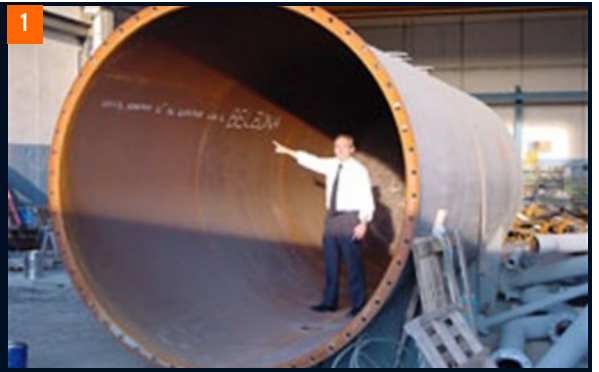
1. The vessel before preparation.
2. Belzona 4311 being applied.
3. The completed application was like a work of art!

Application was carried out in accordance with Belzona Know-How System Leaflet TCC-3. In order to ease application, the vessel was rotated to remove the need for overhead work.
