# BELZONA SOLVES LONG TERM LEAK PROBLEMS AT ELECTRICITY SUBSTATION

ID: 4222

Exterior/rooftop of Super Grid Transformer HV & LV bushings

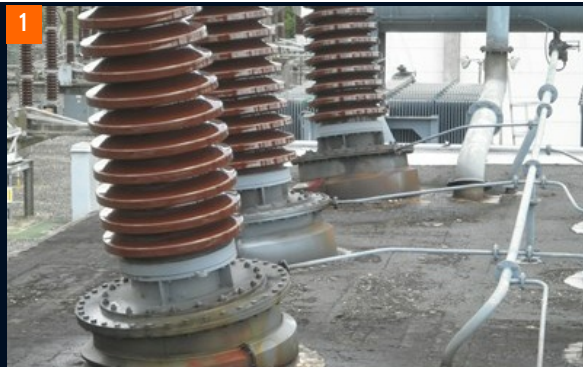
For several years, the transformer had been suffering from extremely high discharges of transformer oil. Following full survey, oil discharges were evident at many of the flange and bolt joints on equipment located in both the interior and exterior of the noise enclosure. A root cause and contributory to the oil leaks were the high voltage and low voltage bushings located to the noise enclosure rooftop.

1. Three HV bushings during survey
2. LV bushing following substrate preparation and masking bolts
3. LV bushing following the removal of one disposable former
4. HV bushing completed including the encapsulation of bolt heads and coating with Belzona 5831 for long term protection

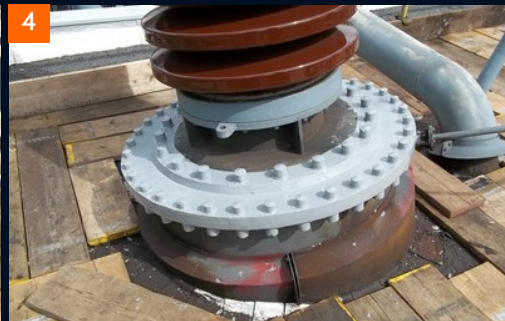
Six bushings were successfully sealed and in recharging the transformer with oil to the correct level, the bushings did not show any visual evidence of leaking.

Application was carried out in accordance with modified versions of Belzona Know-How System Leaflets VPF-8 & 11. After preparing the surfaces active leaks were sealed with Belzona® 1291 or Belzona® 1221. The flange joints were then sealed by applying Belzona® 1161 incorporating Belzona® 9341 (Reinforcement Tape). The bolt and nut heads together with the male studs were fully encapsulated using disposable formers containing Belzona® 1161. Once cured, the formers were removed and all prescribed repair areas were coated with Belzona® 5831.
