# BELZONA TRANSFORMER LEAK REPAIRS ON TERTIARY BOX

ID: 4223

Exterior/Rooftop of Super Grid Transformer Tertiary Box

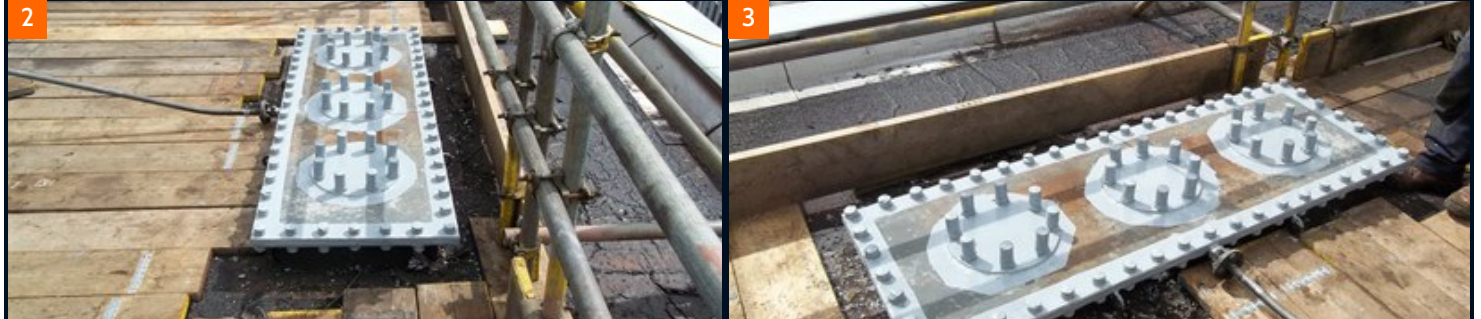
The transformer had been suffering from extremely high losses of transformer oil. Following a site survey, oil discharges were evident at many of the flange and bolt joints to equipment located to both the interior and exterior of the noise enclosure. The root cause of the oil leaks was found to be the tertiary box located in the noise enclosure on the rooftop.

1. Tertiary Box during survey
2. Completed application
3. Completed application

The application was carried out in accordance with modified versions of Belzona Know-How System Leaflets VPF-8 & 11. The tertiary box substrate was prepared before Belzona® 1221 was used to stem any active oil leaks. The flange joint was sealed using Belzona® 1161 incorporating Belzona® 9341 (Reinforcing Tape). Bolt and nut heads, together with male studs were protected by either bridging tape or tight fit former, then fully encapsulated using a disposable former containing Belzona® 1161. Following the curing process, the formers were removed and all of the repair areas were coated with Belzona® 5831.

The leak sealing project was successful. In recharging the transformer with oil to the correct level, neither the flange or bolt heads showed any visual evidence of further leakage. The clients request that the studs be protected prior to encapsulation of the bolt heads was also met.
