# BELZONA MAKES MESSY JOB EASY CLEAN

ID: 4243

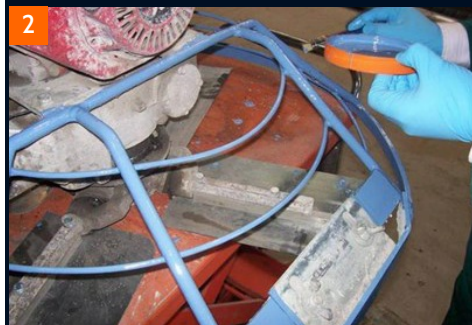
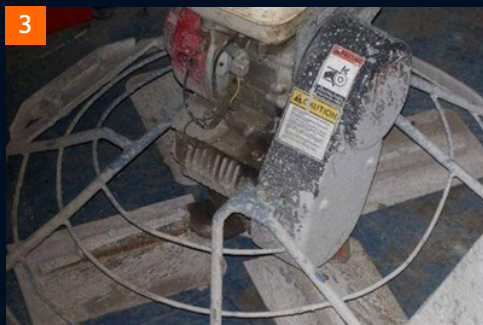
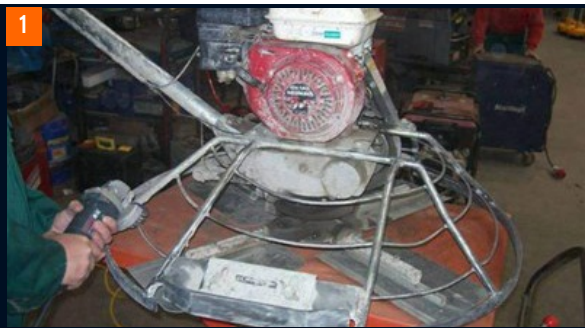
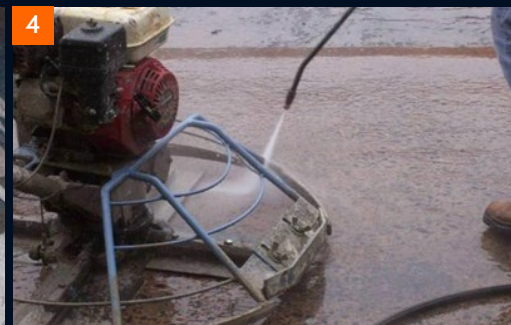
## PHOTOS

It takes someone about an hour with a power washer, hammers, and wire brushes to clean this before the next use. Frequent re-painting of the guard is required as the cleaning process also remove the paint.

During the use of the power floater the rotary guard gathers a lot of concrete that dries on.

1. Surface preparation
2. Brush Application of Belzona 1341
3. After application and first usage
4. Simple cleaning with power washer

Application carried out in accordance with Belzona Know-How System Leaflet VPF-2

The application of Belzona® 1341 has reduced cleaning time by 900-1200%. It now takes just 5 minutes and only requires a power washer!
