# BELZONA 3211 (LAGSEAL) PREVENTS FUTURE UNDER INSULATION CORROSION

ID: 425

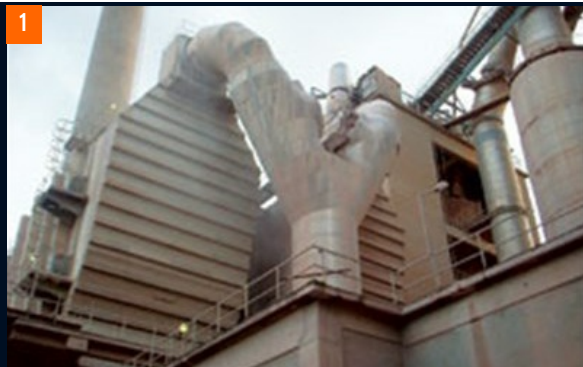
1. View of precipitators
2. Work begins
3. View of precipitator's roof
4. Application complete

The insulation cladding is completely sealed with the Belzona® 3211(Lagseal) System. The entire surface except over the pressure relief valves of two of the four precipitators were protected and sealed with Belzona in six days. Each precipitator was nearly 300 square meters in size.
