# BELZONA PROTECTS CHIP CYCLONE WELD SEAMS

ID: 43

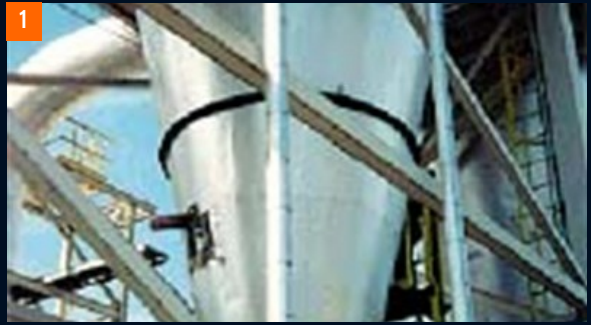
Chip cyclone used to remove oversized chips, pin chips, fines, bark, burnt wood, rotten wood, dirt and foreign materials.

1. Conical shaped chip cyclone.
2. Eroded weld seams of the chip cyclone.
3. Belzona 1321 (Ceramic S-Metal) being used to protect weld seams from future erosion.

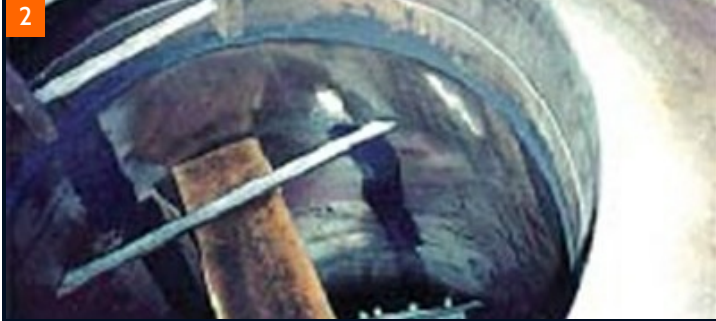
The chip cyclone suffers from continuous erosion, and the irregularities and/or protrusions of the weld seams were attacked.
