# BELZONA PAVES THE WAY TO PARADISE

ID: 435

Bridge, Florida Keys

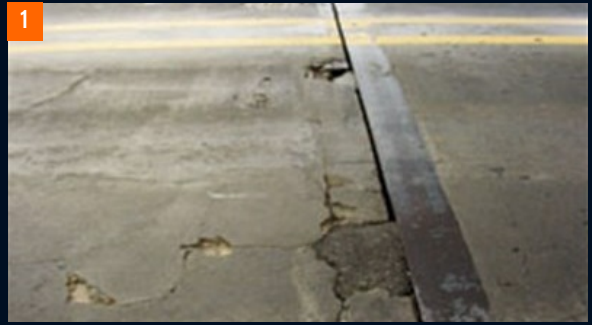
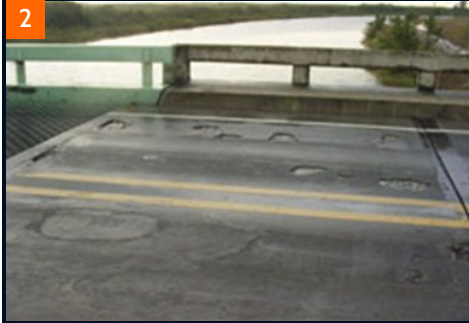
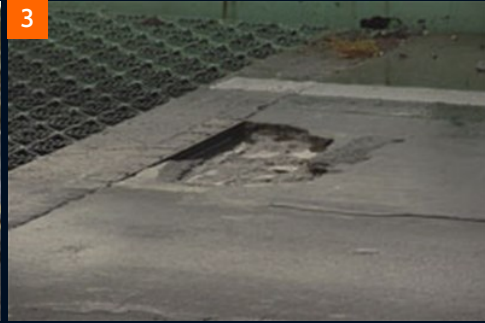
Bridge suffering from thermal cycling, heavy vehicular traffic and vibration, creating potholes and cracks.

1. & 2. & 3. Show various trouble spots

Other conventional repair methods failed in very short time. Belzona® 4151 was mixed with pea gravel. This provided a base layer of material in the cracks and potholes. This was then overcoated with Belzona® 4111. The application took place overnight to minimize traffic interruptions.

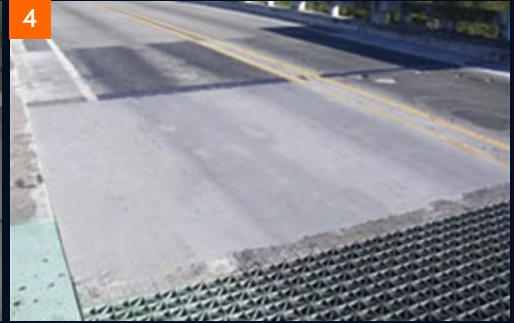
4. Ready for traffic
