# PROCESS VESSEL UPGRADE USING BELZONA ADHESIVE

ID: 459

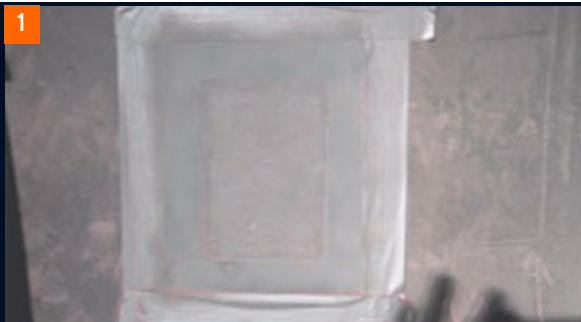
Removal of existing coating to allow adhesive to bond directly to steel substrate. Bonding in of mounting clips and overcoating with Belzona 1391. Sealing of gas demister using Belzona 1111 and Belzona 1391. View of application after 8 years in service

The original coating was removed in localised areas by blasting. The surrounding coating was cleaned and flash blasted. Once completed, mounting clips were bonded into position using Belzona® 1111. The clips were then coated using Belzona® 1391 which was overlapped onto the surrounding prepared coating in accordance with Belzona Know-How System Leaflet TCC-5.
