# BELZONA PROTECTS HYDROELECTRIC DAM COMPONENT

ID: 4656

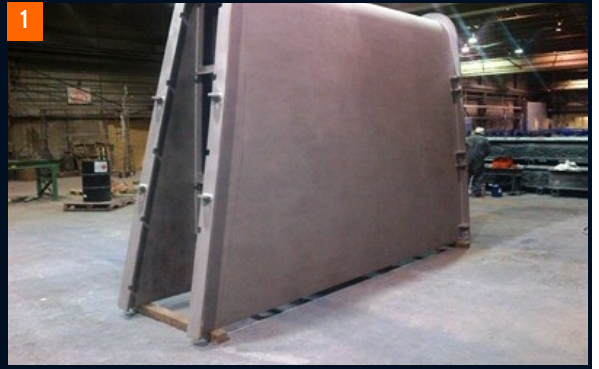
1. Abrasive blasted substrate awaiting coating
2. Application of 1st coat of Belzona 5811 (Grey)
3. Completed application of 1st coat of Belzona 5811 (Grey)
4. Completed application of 2nd coat of Belzona 5811 (Black)
