# CUSTOM MADE TETHERING STRAPS CREATED WITH BELZONA

ID: 4668

Reeled transfer hose for loading/unloading FPSO.

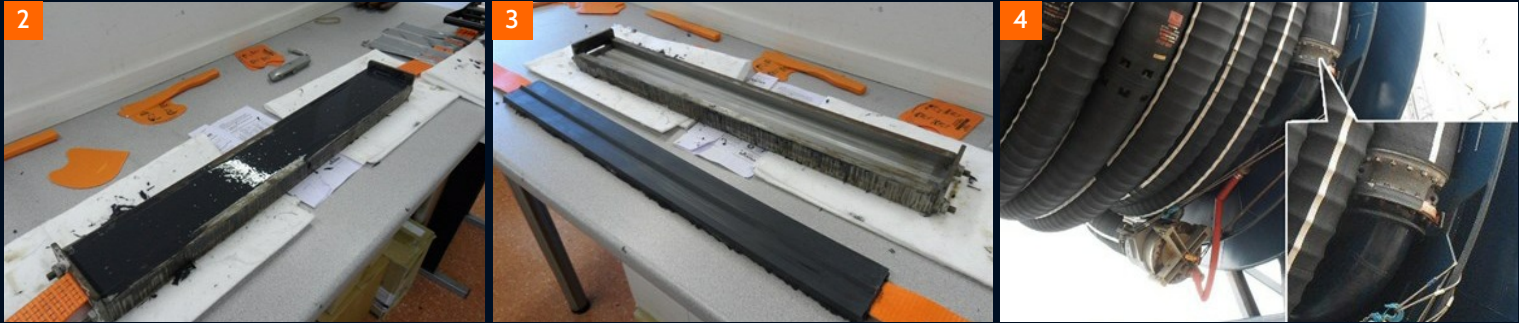
**PHOTOS**

Constant movemernt of the hose was causing friction wear particularly at the initial connection flange. The hose required a secure tether to reduce/stop wear at this location.

- 1. Fabricated mould and Cargo Strap
- 2. Belzona 2221 formed around the strap
- 3. Completed application
- 4. Strap in service

Application was carried out in accordance with a modified version of Belzona System Leaflet SOS-13. Using a specially fabricated mould Belzona 2221 was formed around a cargo strap. The mould accurately formed a location ridge in the Elastomer to match groove in the hose flange.

The strap when ratcheted around the hose flange securely holding the hose, preventing wear on the adjacent hose. This application was originally completed on another unit and has been successfully in service for 4 years. The client was impressed by the solution provided by Belzona and requested an additional two units be created.
