# COMPLEX ROOF WEATHERPROOFED WITH BELZONA

ID: 4676

School boarding house roof with complex geometry.

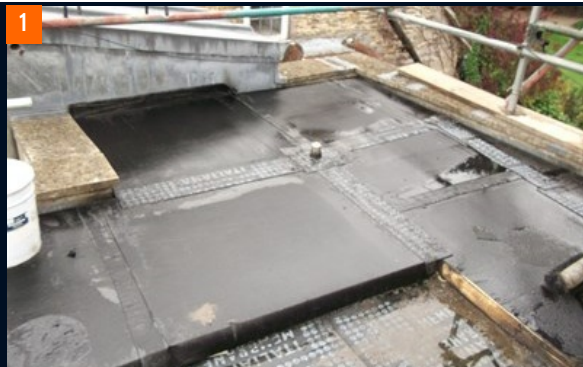
1. Installation of new insulation boards
2. New integrated gutters were created due to the increased thickness of insulation
3. Completed application showing the complex geometry of the roof
4. Completed application showing bonding to several different substrates.

The application was carried out in accordance with Belzona Systems leaflet RPA-8 after installation of new felt back insulation boards.
