# BELZONA PROVIDES HYGEINE SOLUTION FOR SWEET FACTORY

ID: 4696

Crash barrier protection equipment within the production facility.

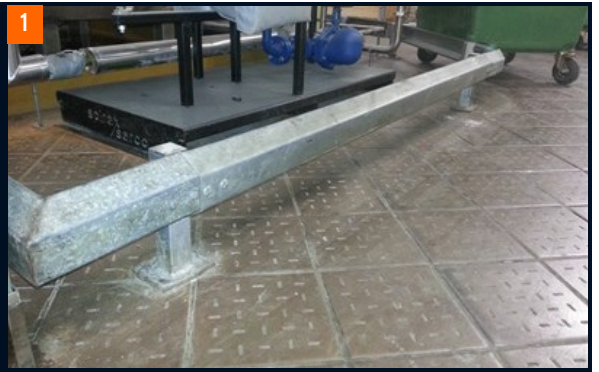
1. Typical crash barrier assembly 2 . Crash barrier base bonded to steel tile 3. Close up after cure

Application was carried out using a midified version of Belzona System Leaflet FPA-11. Both the steel tiles on the floor and steel base of the crash barriers were prepared using an MBX Bristle Blaster before being bonded together using Belzona 1111. Care was taken to ensure Belzona 1111 exuded from all edges and was used to create a smooth fillet around the base.
