# COMPLETE ZONE SAFETY WITH BELZONA

two separate tanker offloading zones for Sodium hypochlorite and Phosphoric acid.

Waste Water Treatment Plant, Teesside, UK

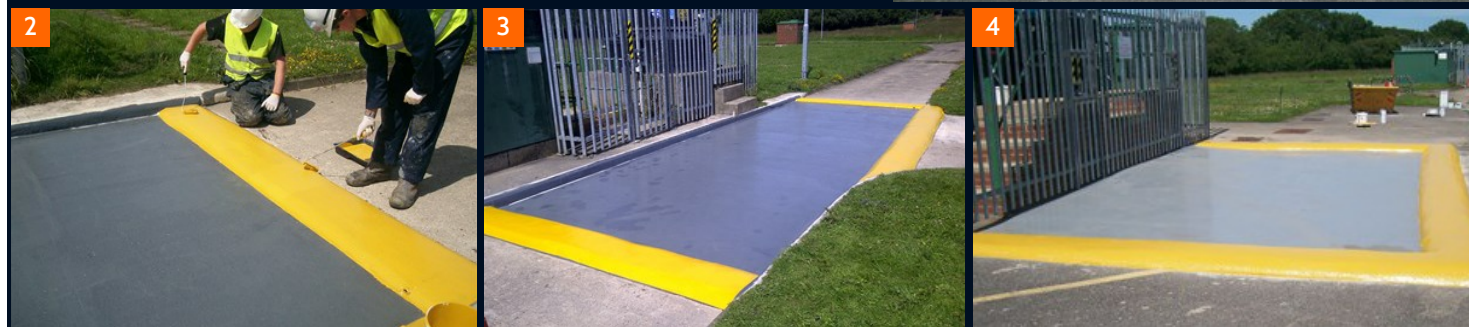
1. Unloading zone before
2. Application in Phosphoric Acid zone
3. Completed Phosphoric Acid zone in Belzona 4311
4. Completed Sodium Hypochlorite zone in Belzona 5811

Application was carried out in accordance with Belzona System Leaflets FPA-1,3, 4 and 6. Concrete repairs were made with Belzona 4131. Areas were coated with either Belzona 5811 against Sodium Hypochlorite or Belzona 4311 against Phosphoric Acid, Belzona 9211 was scattered in the final coat for traction. Expansion joints were filled with Belzona 2111. Finally Belzona 5231 in yellow was used as a demarcation colour on edges and ramps.
