# BELZONA SEALS & WEATHERPROOFS ASBESTOS SCHOOL ROOF

ID: 4731

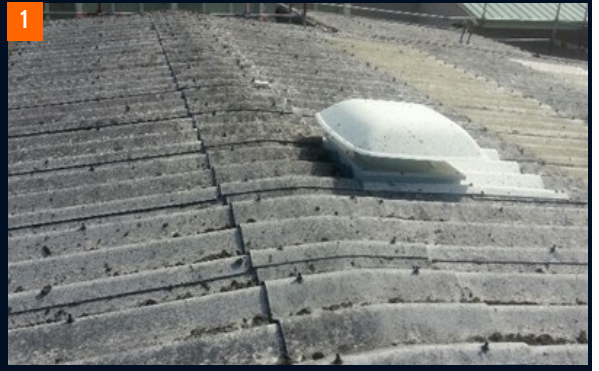
The roof had been leaking for years. Patch repairs had been tried but the water always found another way in. Client requested a complete and long term solution.

1. Before power wash 2. After surface preparation 3. Applying the Belzona 3111 Membrane system 4. Finished section of roof

Application was carried out in accordance with Belzona System Leaflet RPA-1. The roof was power washed with a special filter system used to collect the 'run off'. Belzona 3111 system was then applied to the entire roof area.
