# BELZONA UPGRADES SCHOOL POTWASH FLOOR

ID: 4737

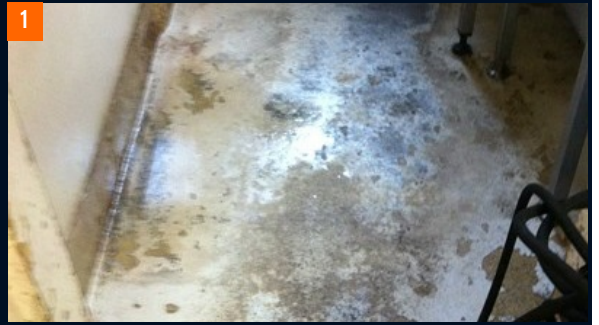
The existing floor coating had only been down 6 months and was failing, trapping dirt and grease and generally not very hygienic. The Belzona solution was selected as it has proven track record, could easily withstand the activity of washing 1000's of dishes a day and that when applied it doesn't give off an odour. Adding aggregate allowed a non slip surface to be created ensuring safety of the staff on what would otherwise be a very slippery floor

1. The pot wash floor before work commenced 2. After being cleaned and grit blasted 3. The pot wash floor after application 4 The loading/sorting area also coated
