# BELZONA CREATES ZONAL FLOOR MARKINGS

ID: 4744

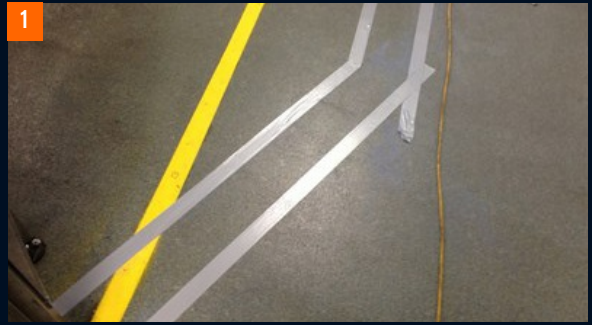
1. Taping out area
2. Zoned area
3. Completed application

The Application was carried out in accordance with Belzona System Leaflet FPA-08. The areas were roughed with floor grinders. The desired pattern was then taped out. Two coats of 5231 were then applied. A stencil was used to denote the 'zoned area' floor marking.
