# BELZONA COATS SUPER YACHT

ID: 4805

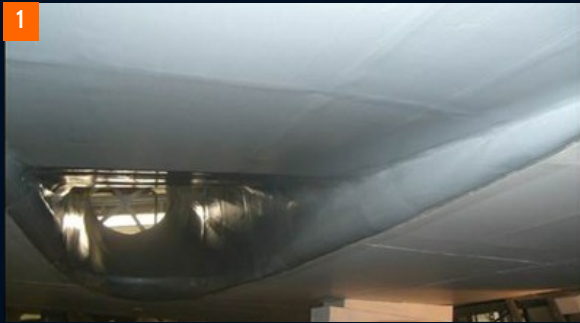
1. Jet tubes coated with Belzona 1341
2. 1st coat of Belzona 2141
3. 2nd coat of Belzona 2141 applied
4. After three years in service local repair was carried out on leading edge

Application was carried out in accordance with Belzona Know-How System Leaflets SOS-1 & SOS-2. Rebuilding of the damaged area was carried out using Belzona 1111, before being coated with the Belzona 2141 system to provide cavitation resistance. Belzona 1341 was used as the first coat to provide optimum adhesion and corrosion resistance.

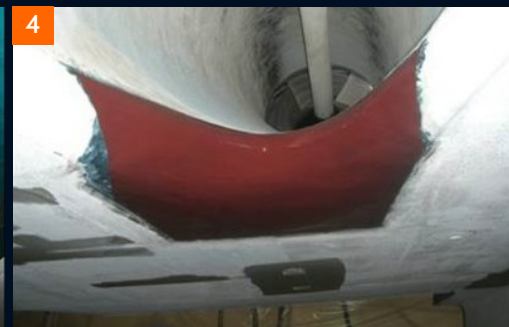
Belzona was inspected after 3 years and was mostly found to be in perfect condition with only minor damage to the leading edge. The coating had overcome the major cavitation erosion problems and was easily repaired with minimal downtime.
