# NON-COMPLIANT WRAP KEEPS 30" LINE IN SERVICE

ID: 4812

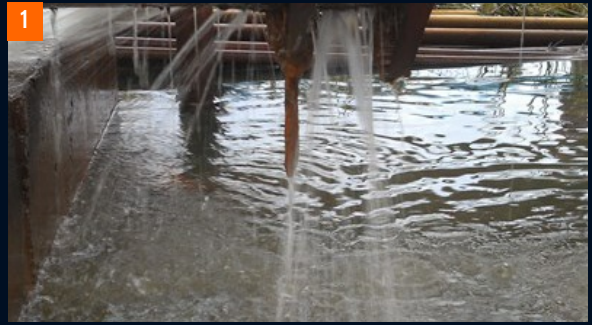
1. 30" diameter effluent line at a petroleum terminal in NJ.
2. Holes and thin wall revealed.
3. Applying a second layer of Belzona 1111 over the first wrap.
4. Two coats of Belzona 5811 was applied over the finished wrap repair.

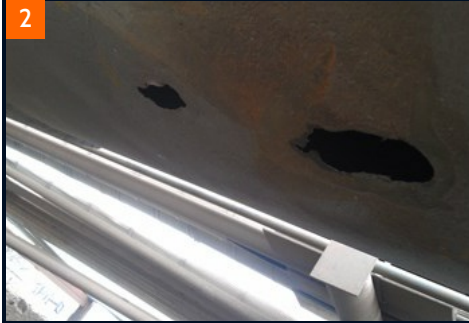
Holes and thin wall.

The 30" diameter effluent line had three separate areas where corrosion and thin wall pipe allowed a large amount of water to pond near an access walk and traffic area. With winter coming, the plant wanted to fix the leaking piping and eliminate the potential safety issues of icy conditions on the access walk and traffic area. Operating pressure is <5 psi. Water would have to be diverted from the piping for repairing three (3) separate areas.

Surface was prepared by abrasive blasting to SSPC-SP10 near white. Patches were made to holed areas using Belzona 1111/Belzona 9341 in accordance to a modified version of VPF-11a, Low Pressure. Then Belzona 1111 was applied to the entire outer surface and wrap of Belzona 1971 wetted out Belzona 9371 was applied with a 50% overlap. A second layer of Belzona 1111 was applied along with a second wrap of Belzona 1971/Belzona 9371. It was completed by adding a Belzona 5811 coating.
