# BELZONA PROTECTS HORIZONTAL FLARE KNOCK OUT VESSEL

ID: 487

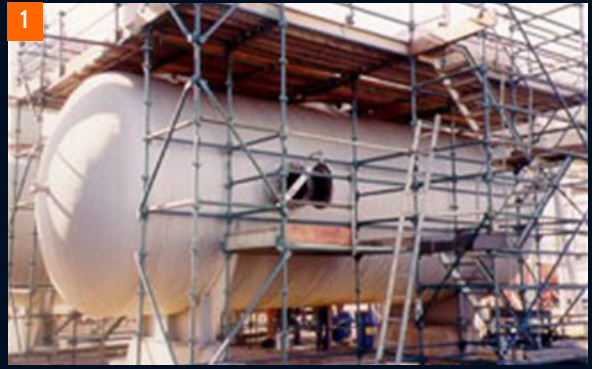
1. Access to vessel
2. & 3. Localised pitting being infilled
4. Completed application to lower section of the vessel

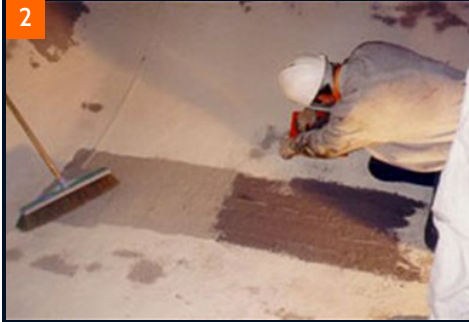
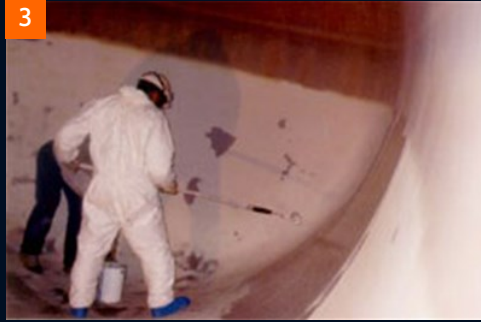
Corrosion in lower third of vessel where water sits. Vessel removes liquid hydrocarbon drop-out, H<sub>2</sub>S and traces of HF.

Application was carried out in accordance with Belzona Know-How System Leaflet TCC-5. After thorough cleaning, the vessel was grit blasted and coated with the Belzona® 5891.
