# BELZONA PROTECTS PELTON TURBINE NOZZLE HEAD

ID: 4875

Hydro power plant, Kaunertal, Austria

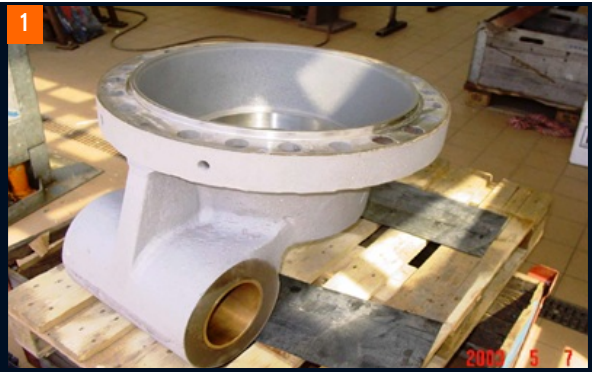
1. Nozzle head after grit blasting
2. Application of Belzona 2141
3. Completed application before installation in May 2003
4. After more than 10 years of operation Belzona 2141 in perfect condition

Application was carried out in accordance with Belzona System Leaflet VPF-2. After preparing surface by grit blasting (80 micron profile achieved) Belzona 2141 system was applied at 1mm thickness.

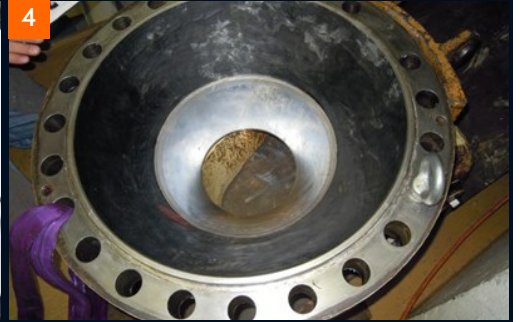
The Belzona system was originally applied in May 2003 and when inspected in February 2014 after more than 10 years in service was found to be in perfect condition.
