# BELZONA SETS IN PLACE BRASS SLIDER PLATES ON A DRAGLINE

ID: 4884

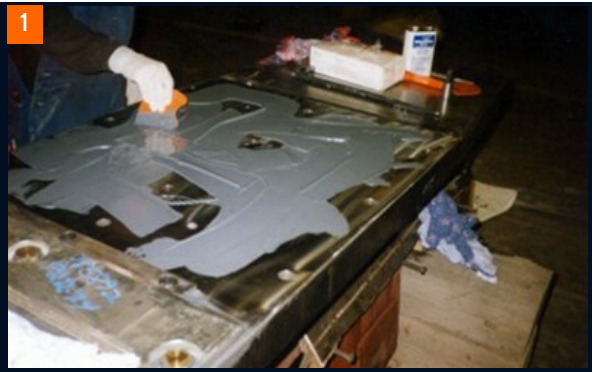
1. Prepared surfaces coated with a 40 mil thickness coat of Belzona 1321
2. Applying Belzona 1321 on other plates
3. The brass wear plates were inverted and the bolts torqued in place creating 100% contact

Belzona 1321 was floated in place to provide a non-shrinking shim successfully solving the problem.
