# INVISIBLE WATERPROOF COATING FOR EXTERNAL WALLS

ID: 4905

Exterior walls of Industrial building.

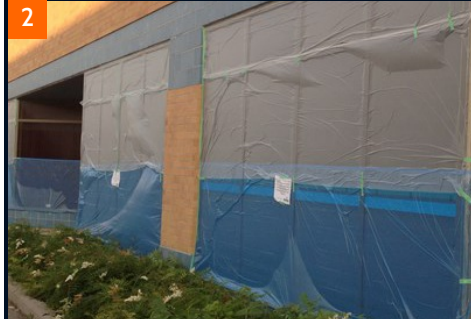
Water was penetrating the brick and mortar, creating damp areas on internal wall.

1. Walls prior to application
2. Preparation completed
3. Application underway
4. Completed application
