# BELZONA PROTECTION OF OIL SKIMMER DISCHARGE PIPE

ID: 491

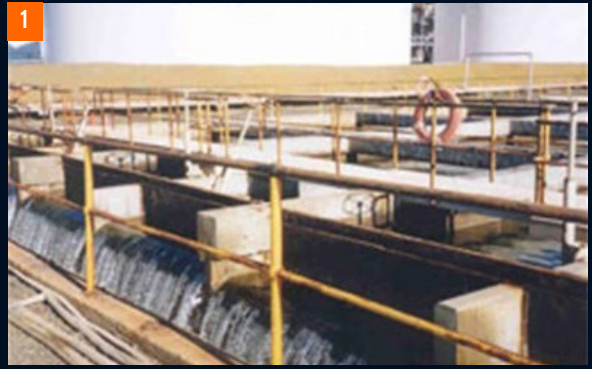
Concrete pipe discharging the clean water from the oil skimmer into the sea.

1. General view of the Oil Skimmer.
2. Belzona 4211 being used to seal leaks.
3. Joints smoothed out with Belzona 1111 prior to coating.
4. Completed application with Belzona 5811 applied to entire surface of the pipeline.

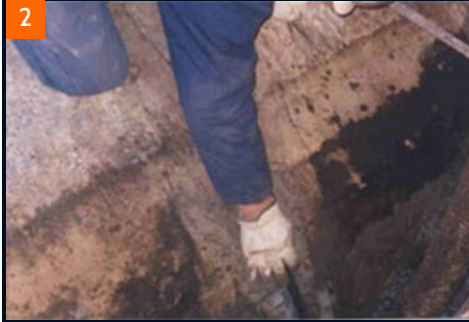
Joints were leaking and external protection of the concrete required.

Application was carried out in accordance with Belzona Know-How System Leaflet VPF-11b. After sealing leaks with Belzona® 4211, Belzona® 1111 used to smooth out joints, then Belzona® 5811 applied to protect all external surfaces of the pipeline.

Belzona® 4211 effectively sealed live leaks without interrupting operation of the skimmer which prevents oil pollution of the sea.
