# INTERNAL COATING FOR CENTRIFUGAL PUMP

ID: 4922

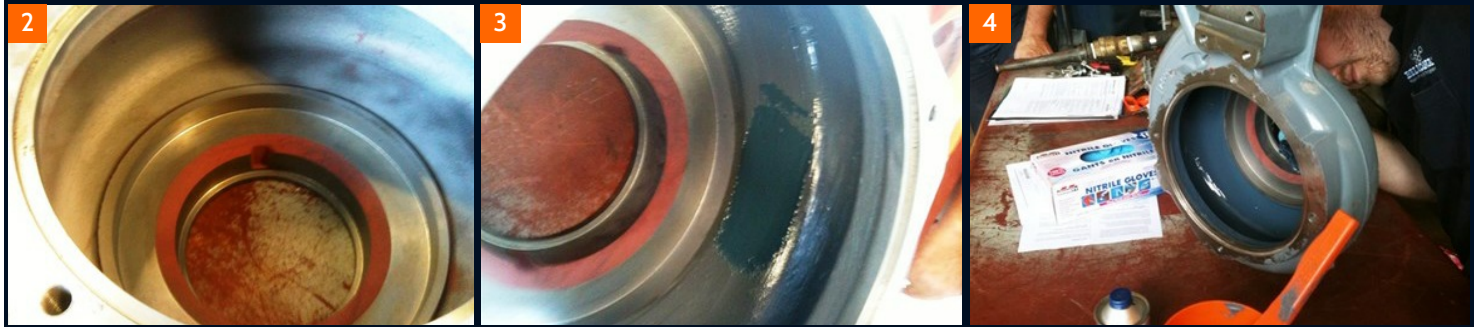
## PHOTOS

A customer wanted to protect and expand the life of a new pump due to installed at the plant to replace the existing pump which was suffering from corrosion/erosion due to sewage waste.

1. Centrifugal Pump Prior to Application
2. Preparation Complete
3. Application
4. Completed Application

Application was carried out in accordance with Belzona Know-How System Leaflet CEP-3. The surface was prepared by grit blasting the entire surface to be coated, brushing away any loose contamination and washing the surface with Belzona 9111. Belzona 1321 was applied directly on to the prepared surface with a stiff bristle brush in accordance with the Belzona Instructions For Use.
