# BELZONA PROTECTS 50,000 SQ.FT FLOOR AREAS OF A TECHNOLOGY CENTER & LABORATORY

ID: 4932

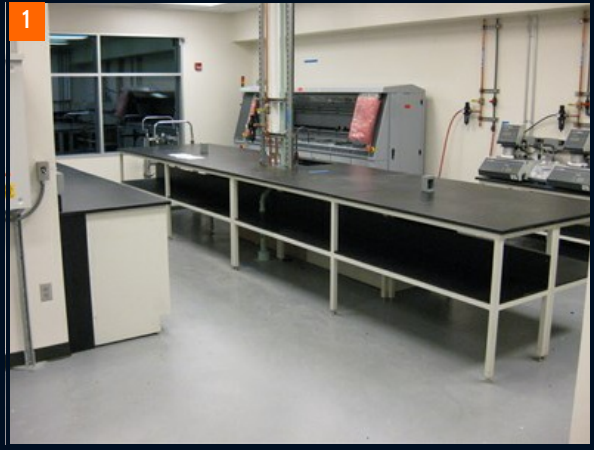
1. Laboratory floor areas protected with Belzona 4311
2. Laboratory floor areas protected with Belzona 4311
3. General floor areas protected with Belzona 5811
4. Laboratory floor areas protected with Belzona 4311

Application was carried out in accordance with Belzona Know-How System Leaflet FPA-3, following the 28 day curing process of the newly poured concrete. Belzona 5811 was applied to general floor areas and Belzona 4311 - to laboratory floors. The application of the coating systems was successfully completed using a combination of squeegee and paint rollers.
